DPL UV

Grease & Odour Control System

Case Study.

London Project - Brief

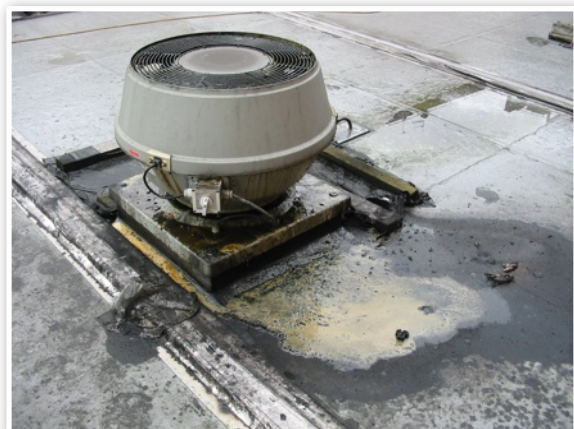
Although the fan unit and canopy had been correctly sized and the duty from the fan was acceptable, there was evidence that the filtration was completely ineffective and that there was no means of controlling the odours.

The fan was completely fouled with cooking fat and a large pool of grease had formed around the roof opening.

*Image 1
The original fan unit, fouled with grease from ineffective filtration.*

Our goal was to firstly improve the primary grease filtration, removing as much of the grease from the cooking vapour as possible then to provide an effective solution to the remaining odour problems.

Mesh grease filters are no longer acceptable for use in commercial kitchens. These were removed and replaced with DPL stainless steel, centrifugal Baffle filter panels. These are capable of removing almost double the amount of grease as well as being more hygienic, simpler to maintain and clean and reduce the risk of fire.

Due to cost restraints, it was decided that the canopy would not be replaced. The odour removal system must therefore be separated from the canopy. For this we designed a roof-mounted grease and odour removal system, housed in a weatherproof enclosure.

The existing fan unit was removed – to be replaced by a more powerful, quieter and more efficient centrifugal unit. A Systemair MUB unit, fitted with the EC low-energy, external rotor motor, was chosen due to its high performance and quiet operation and reduced running costs. With speed control available from the DPL UV Controller, as well as monitoring of fan performance, filter condition and UV lamp condition – we were able to provide a 'one-box' installation for the entire system.

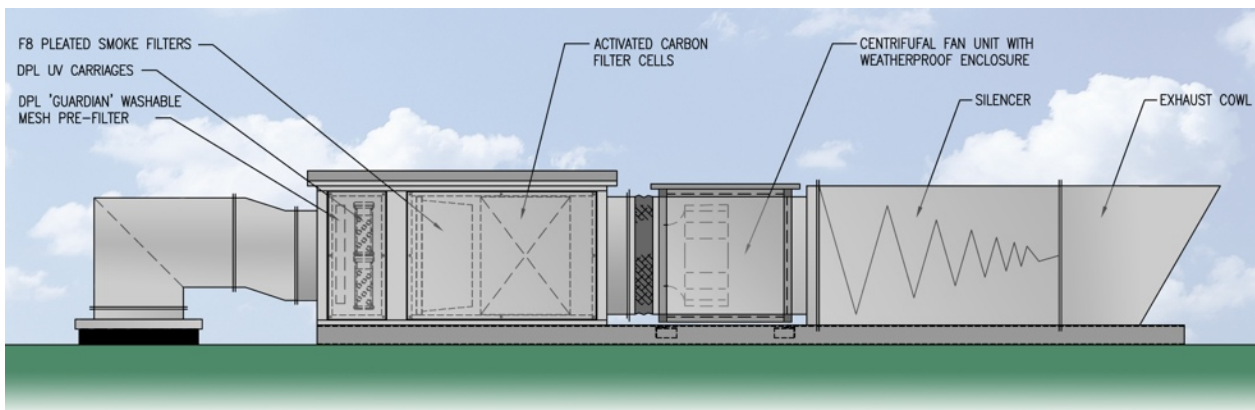
DPL UV Odour control diagram

The unit comprises of the following elements:

- Secondary filtration – following the primary filtration (at the canopy) a washable, wire mesh, impingement filter to remove the larger grease particles carried over from the cooking vapours.
- UV Filtration – two DPL UV cartridges fitted with ozone generating UVC lamps to effectively 'pull apart' the odour producing molecules, breaking down the compounds and destroying any remaining traces of grease from the air stream.
- Smoke filters – rigid pleated smoke filters to capture residual particles following the Ozone / UVC reaction.
- Carbon cells – Activated carbon cells provide a means of holding the ozone laden air, allowing the ozone to fully react with grease compounds, for remaining oxygen free-radicals to combine and remove the remaining odours before being released into the atmosphere.

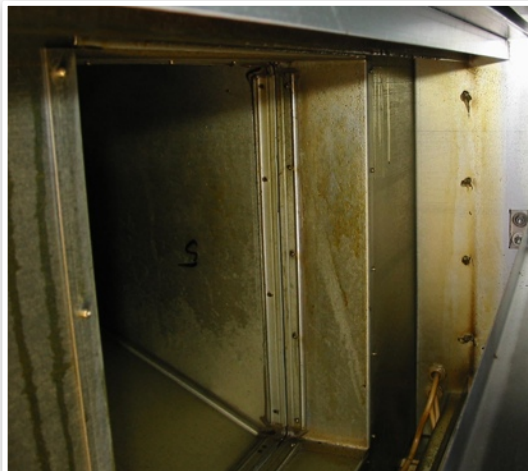
Image 2.

There was a marked difference in the condition of the unit at either side of the UV cartridge. Within the duct, the grease carry over had covered the internal surfaces and there was a heavy coating on the secondary mesh filter. The internal surfaces of the odour removal housing were similarly coated.

The image shows the opening of the duct as it enters the odour control housing with the secondary mesh filter panel removed. The coating of grease can be seen covering the internal duct surfaces.

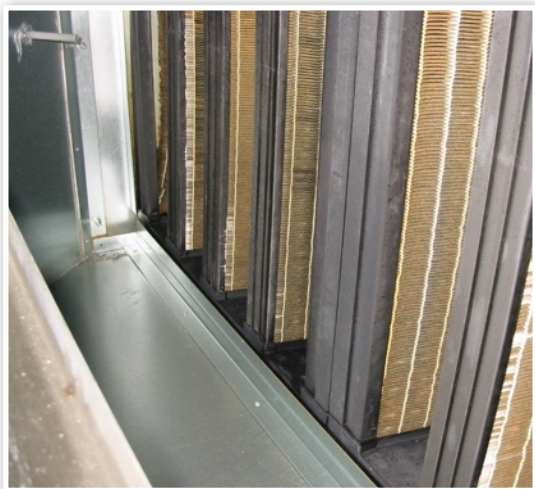
Image 3.

In contrast, the appearance of the components beyond the UV cartridges remained clean and grease free.

Beyond the carbon filter cells, the silencer and fan unit were also completely clean and grease free.

The image shows the area immediately downstream of the UV carriages (removed for clarity).

The internal surfaces of the housing are completely clean with almost no evidence of grease. The smoke filters can be seen to the right of the image having captured the fine powdery residue following the ultra-violet / ozone reaction process.

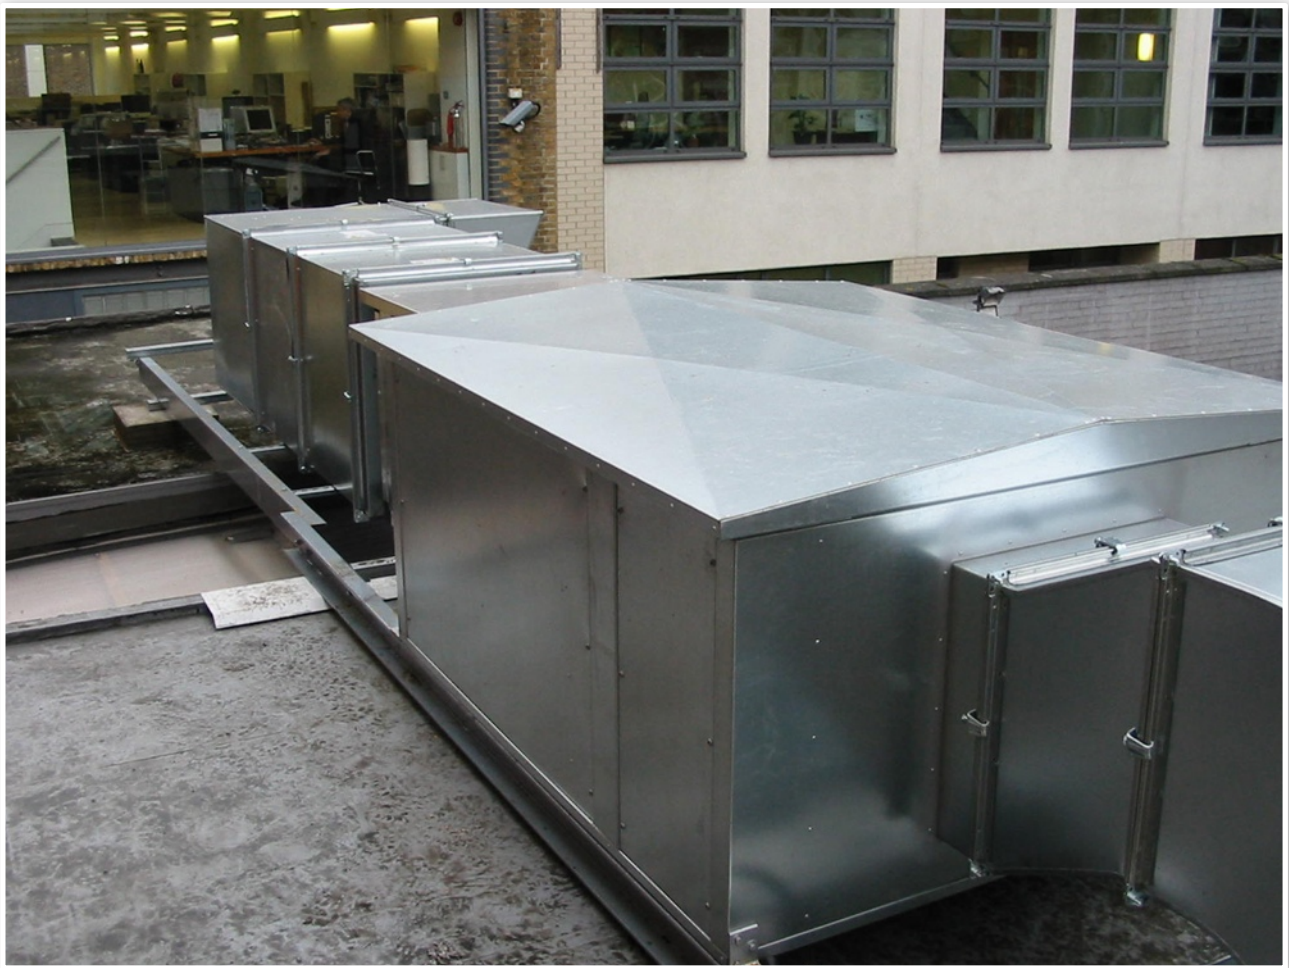
Image 4

The DPL UV grease and odour control system installation.
